BORONIA & SURROUNDS, MOSMAN

CONSERVATION MANAGEMENT PLAN (CMP)

Prepared for
MOSMAN COUNCIL

by
OTTO CSERHALMI & PARTNERS
ARCHITECTS

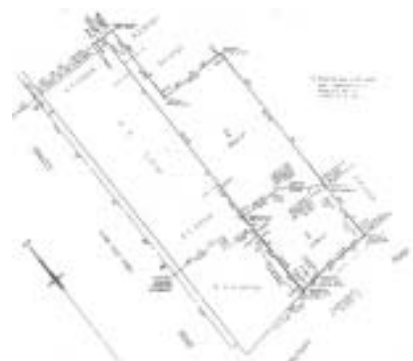
c. 1957 Subdivision Plan of Boronia (Source: Mosman Council Files)

A c. 1957 Land Title Plan of Boronia shows the subdivision of the site into two allotments. The Council continued to hold ownership of both properties and used the northern allotment (Lot 2) for use as a council depot and nursery. The Council also continued to use the right-of-way easement across the Commonwealth land to access Cowles Road.

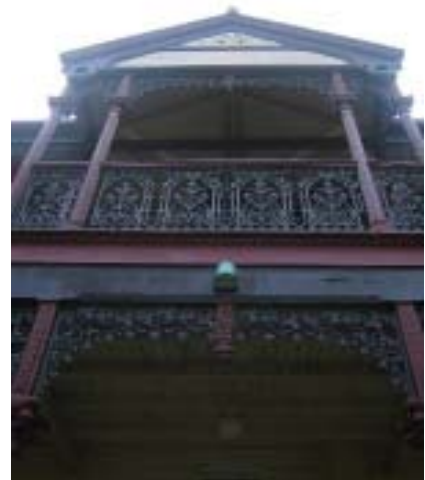
View of verandah from south with decorated cast iron panels, 2007 (Source: OCP)

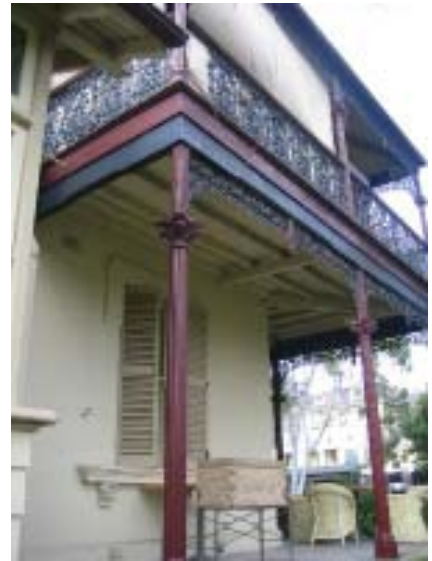
Cast iron columns and decorative cast iron balustrade, 2007 (Source: OCP)

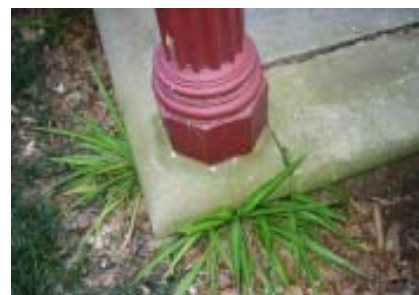
Subsidence of the south-east corner of verandah plinth, 2007 (Source: OCP)

The verandah platform/plinth and the front steps need attention. The flooring of the verandah is concrete screed, which is patchy and unevenly finished and is showing signs of failing especially at the edges.

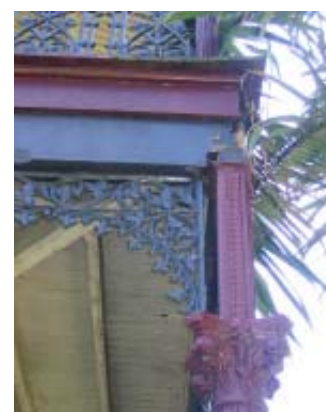
Severely damaged timber beam south-eastern verandah corner, 2007 (Source: OCP)

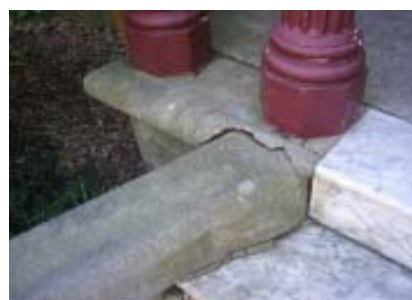
Cracks in verandah caused by sinking of front steps and parapet wall, 2007 (Source: OCP)

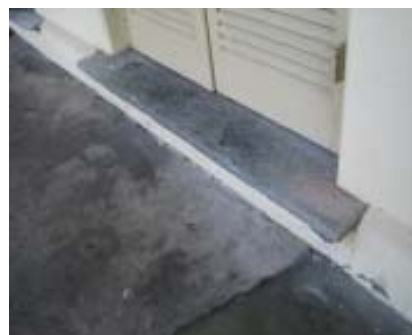
Delamination of slate thresholds of French doors, 2007 (Source: OCP)

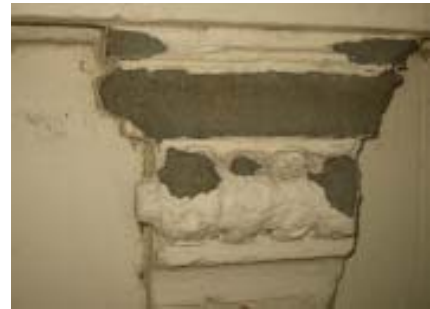
Deteriorated bracket underneath window sill, 2007 (Source: OCP)

The only window that opens out onto the verandah is located on the western side of the ground floor verandah and, its shutters which are the same as those for the French doors are original and in good condition. There is also a decorative rendered label moulding around the top half of the window. The window sill is made of stone and is deteriorated. The two brackets underneath the sill need repair or indenting. It is not clear whether these are stone or cast cement. If stone they have been extensively patched.

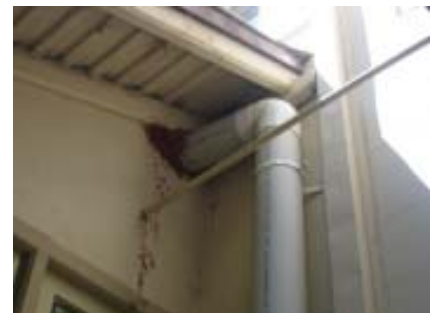
PVC pipe along glazed bay area with urethane sealant having leaked out of gaps, 2007 (Source: OCP)

The shingles of the glazed bay area need to be repainted and the rendered sandstone base needs to be re-pointed with lime mortar. A recently added pvc pipe - which carries drink dispensing pipes - is on the south wall of the glazed bay area. It has been crudely inserted and gaps filled with unsightly expanding urethane. This service should be rerouted more discreetly and the wall made good. The rainwater downpipe on the western face of the glazed bay area has splits in the pipe filled with foam rather than being soldered. The gutters for the skillion roof need to be cleaned as they are full of leaves and have sagged badly. A single bulb light fitting is hanging loose and needs to be attended to as it is dangerous. The steps leading down to the garden are nearly blocked by a newly constructed low height wall and lattice fence that encloses the garbage area. This should be removed or modified in the future to allow use of the stairs. Consideration should also be given in the future to relocating the garbage area as it is too close to the house and the glazed bay area.

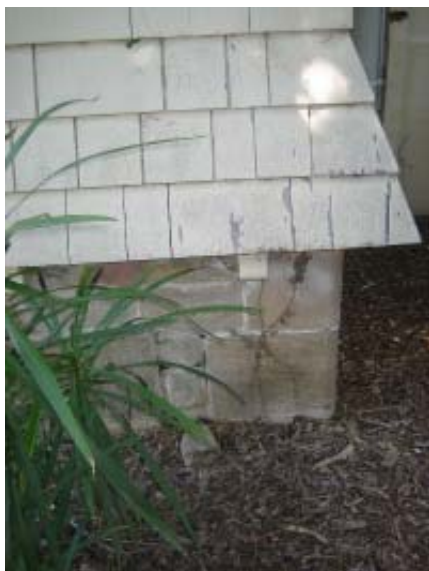
Deteriorated paint to wooden shingles on glazed bay area wall, 2007 (Source: OCP)

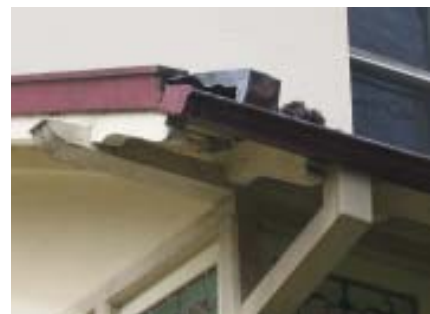
Skillion roof gutter sagging and full of leaves, 2007 (Source: OCP)

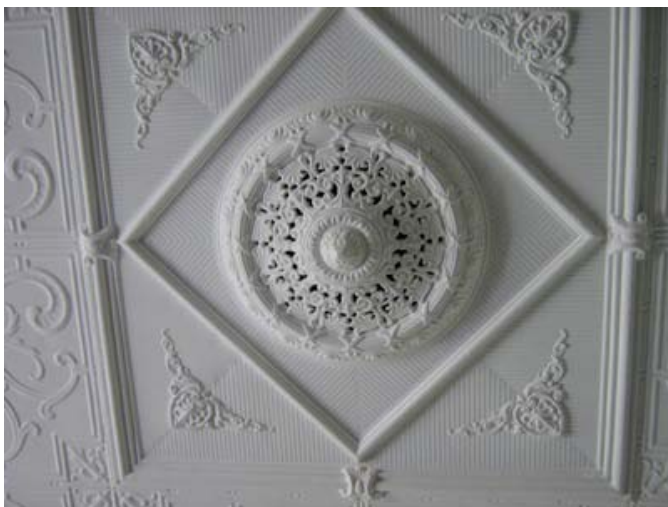
*Original metal pressed ceiling,
2007 (Source: OCP)*

The ceilings of the 1890 addition (A7) are pressed metal, generally in good condition including cornices. The location of the former chimney breasts can be seen in the pressed metal which has been patched in these areas.

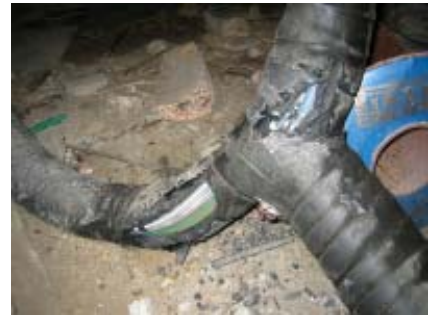
Sub-floor, damaged drink dispensing pipe, 2007 (Source: OCP)

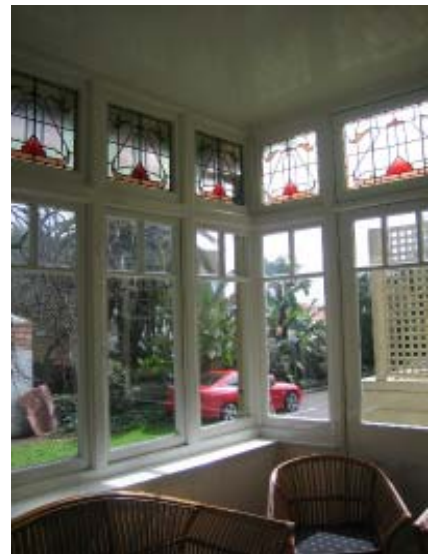
Glazed bay area subsidence problems causing gaps to develop in window and door frames, 2007 (Source: OCP)

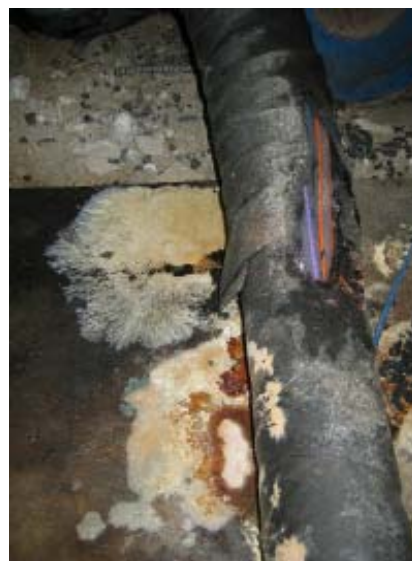
*Eroded drink dispensing pipe, 2007
(Source: OCP)*

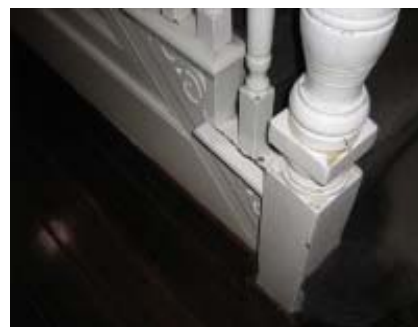
*Cracks in treads of staircase, 2007
(Source: OCP)*

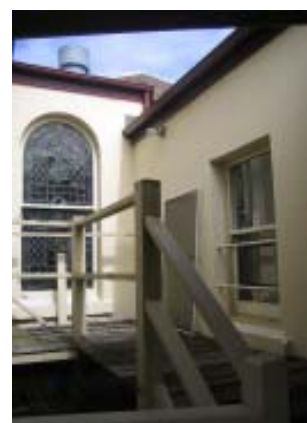
Staircase and landing of lattice covered verandah, 2007 (Source:OCP)

There is also a small modern two-storeyed lattice covered verandah at the back of the building (A11), which abuts the kitchen on the ground floor. A staircase leads to the toilets and store areas on the first floor. Both the verandah and the stairs were added in 1986 to provide alternate means of egress from the upper floor.

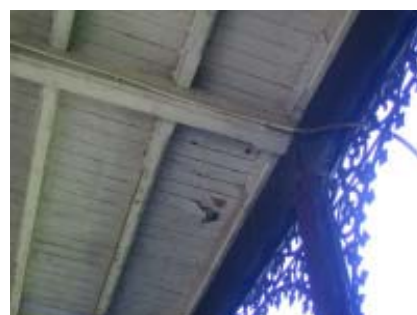
Metal roof of verandah has leaks and peeling paint, 2007 (Source:OCP)
